τεχνικό εγχειρίδιο τοποθέτησης & συντήρησης ιμάντων

Installation and Maintenance Instructions

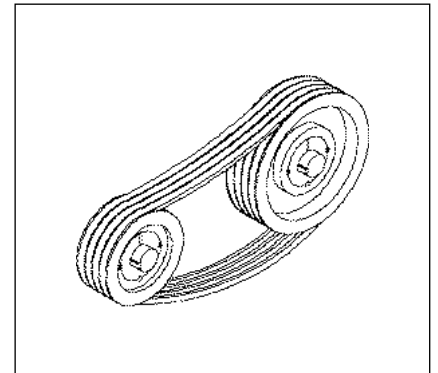
V-belts should be installed without using force. Installation using screwdrivers, crow-bars etc. causes internal and external damage to the belt. V-belts installed by force may in some instances only work for a few days. Correct installation of the belt saves time and money.

If installation allowance is limited, it may be necessary to fit the belts to the pulleys and then attach them to the shafts.

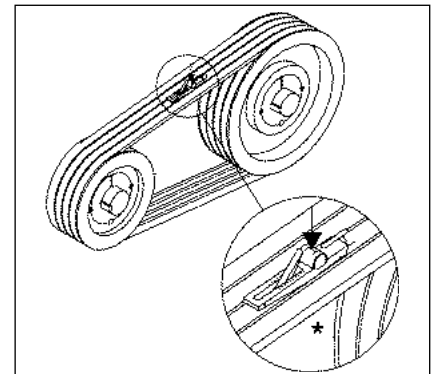
Belt tension values should follow OPTIBELT recommendations. Align the motor parallel up to the stated belt tension. Carry out several belt revolutions and check static belt tension again. Experience has shown that belt tension needs to be checked again after 0.5 to 4 hours and then corrected, if necessary. For further information on tensioning gauges and how to use them see page 5.

* Optikrik

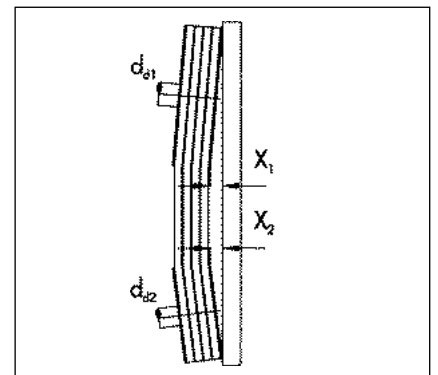
After tightening to the correct initial installation tension, the distances X_1 and X_2 between the two pulleys d_{d1} and d_{d2} and the guide rail at shaft level should be measured. The distances measured should ideally fall below the maximum permissible values for the distance X from the table, depending on the pulley diameters d_d . According to pulley diameter, the interim values for X are to be interpolated.

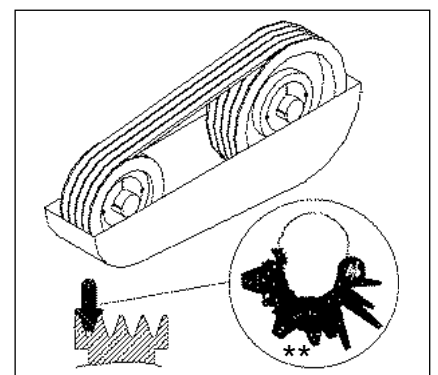
We recommend that the drive should be inspected regularly, e.g. after 3 to 6 months. V-grooved pulleys should be checked for wear and tear and overall condition. As an aid, you are advised to use the OPTIBELT section and pulley groove template.

** section and pulley groove template

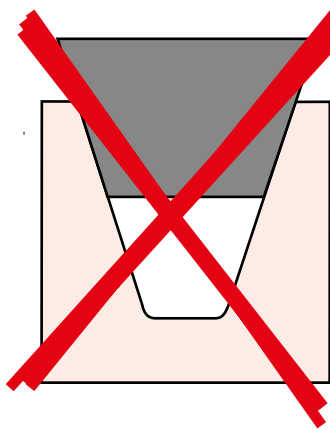
Correct belt arrangement in the V-grooved pulley

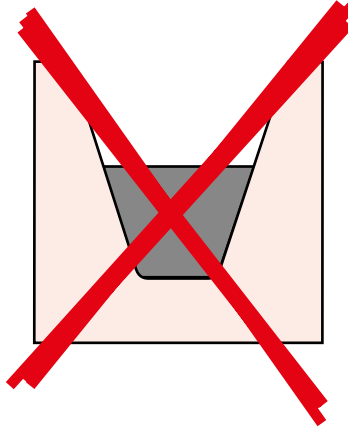
Belt too big/
pulley groove too small

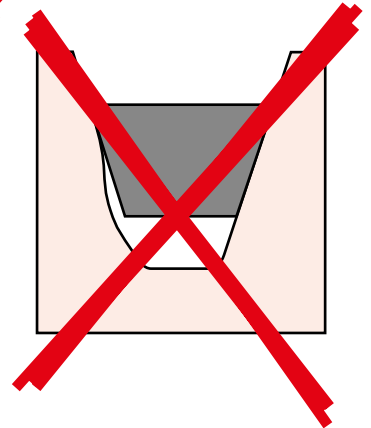
Belt section too small/
pulley section too big

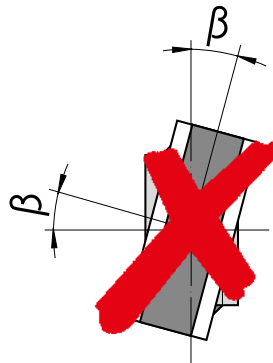
Installation by force

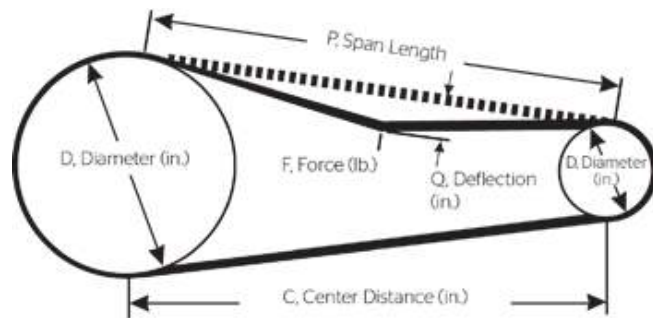
Deflection Principle

F = Deflection Force

q = Deflection, 1/64 in. per in. of span length

C = Center Distance

D = Large Sprocket Pitch Diameter

d = Small Sprocket Pitch Diameter

P = Span Length

$$P = \sqrt{C^2 - \left(\frac{D-d}{2}\right)^2}$$

4. Using a tape measure, measure the span length of the drive. Refer to dimension "P" in the diagram. The span length can be calculated using the formula at the right.

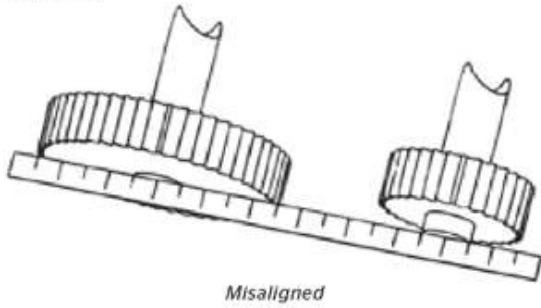
Figure A

With parallel shafts, misalignment occurs when there is an offset between the sprocket faces as in Figure A. Misalignment also occurs when the shafts are not parallel as in Figure B.

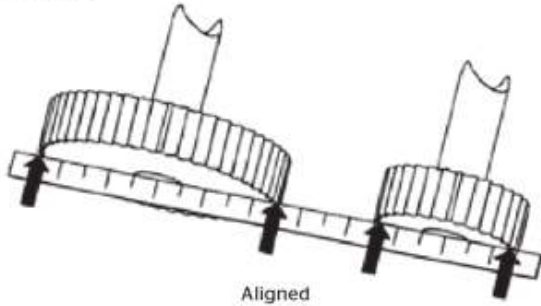
Figure C

Any degree of misalignment will reduce belt life and cause edge wear. Therefore, a straightedge should be used to check proper alignment verifying that sprockets and shafts are parallel, as in Figure C.

Correct alignment

A straightedge should touch the sprocket at the four points indicated. Both front and back alignments should be checked.

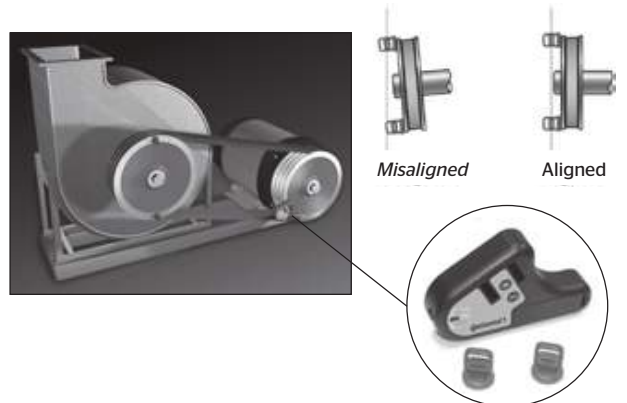
Laser alignment tool

Continental ContiTech Laser Alignment Tool provides an alternative to checking alignment with a straightedge. Each laser alignment tool comes with a rugged carrying case and detailed instructions to get you started with the quickest, easiest and most versatile alignment tool on the market today.
